Technical Notes

Surgical technique for collateral ligament avulsion fractures of the proximal interphalangeal joint with a rotated bony fragment

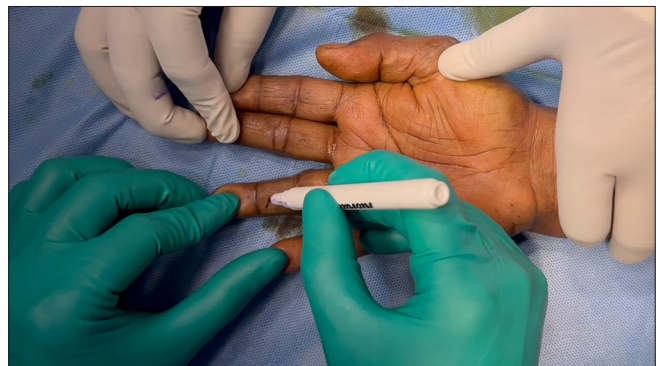
Video 1: Intraoperative video demonstrating the step-by-step approach to open reduction and K-wire fixation of the volar plate and radial collateral ligament injury with bone avulsion.

A meticulous skin incision is marked, typically a Bruner-type or mid-lateral incision centered over the affected PIP joint [Video 1]. The incision should provide adequate exposure to both the volar plate and the injured CL. The skin and subcutaneous tissues are carefully dissected and elevated, protecting the neurovascular structures. The dissection proceeds down to the avulsed volar plate and the involved CL (radial or ulnar). The small bone fragment attached to the volar plate and CL is often found rotated, with its articular surface facing the fracture site at the base of the middle phalanx. Carefully dissect the fragment to ensure it is free from any adhesions, paying attention to the flexor tendon sheath.

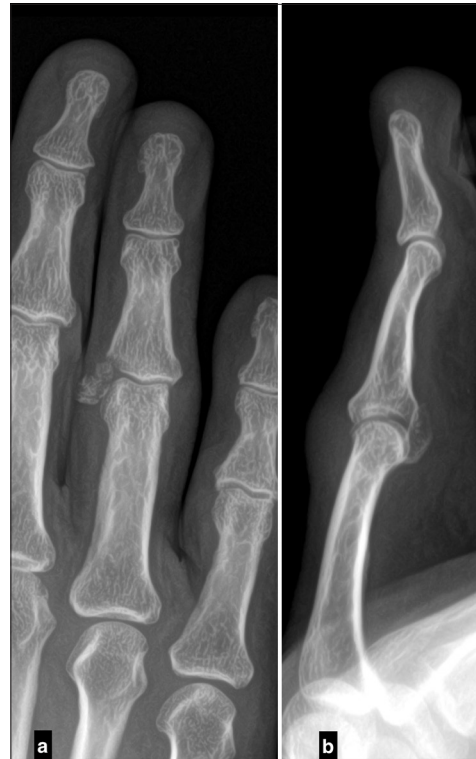
Figure 1: (a) Anteroposterior and (b) lateral radiographs of the right ring finger demonstrating a volar plate avulsion fracture with an associated radial collateral ligament avulsion.

A 62-year-old right-hand dominant woman presented to our clinic with right ring finger pain, swelling, and restricted motion following a chain-snatching incident 1 week prior. During the incident, she sustained a severe injury to her finger while resisting the assailant. She had not received any prior treatment. The right ring finger PIP joint was tender to palpation with an apparent volar prominence on examination. There was a limited range of motion with pain in both active and passive movement. Radiographs demonstrated a volar plate avulsion fracture with an associated radial CL avulsion [Figure 1]. A computed tomography (CT) scan confirmed that the bony fragment was rotated 90° and separated from the

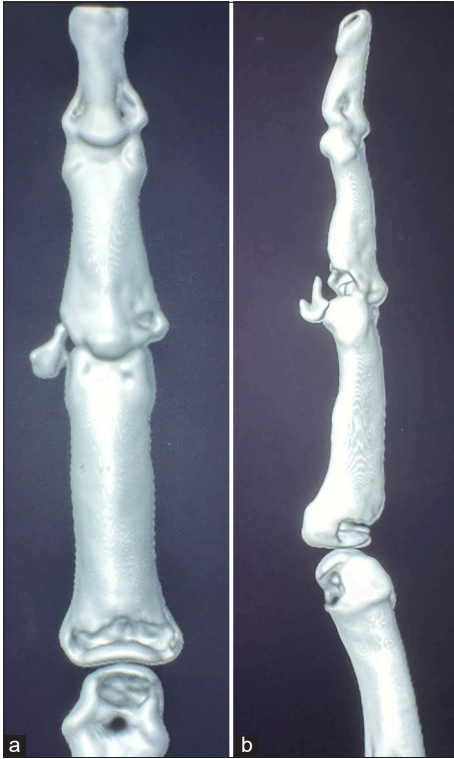
Figure 2: (a) Coronal and (b) sagittal computed tomography scan images confirming the avulsion fracture and demonstrating the displacement of the fragment.

middle phalanx base [Figures 2, 3]. While magnetic resonance imaging (MRI) is not always necessary in these cases, as the bony injury and displacement are typically well-appreciated on CT, it was obtained in this instance to evaluate further the extent of soft tissue injury, particularly the volar plate and CL complex. The MRI confirmed the volar plate avulsion and radial CL injury with the associated bone fragment [Figure 4]. Given the displacement and instability, we proceeded with open reduction and internal fixation. A Bruner-type incision was made over the radial aspect of the PIP joint. Careful dissection exposed the avulsed volar plate and radial CL [Figure 5]. The small bone fragment was identified and reduced anatomically to the base of the middle phalanx. A 1.2 mm K-wire was used to secure the fragment, advancing it from volar to dorsal across the fracture site [Video 1]. The radial CL was then repaired using non-absorbable sutures passed through the volar plate for augmentation.

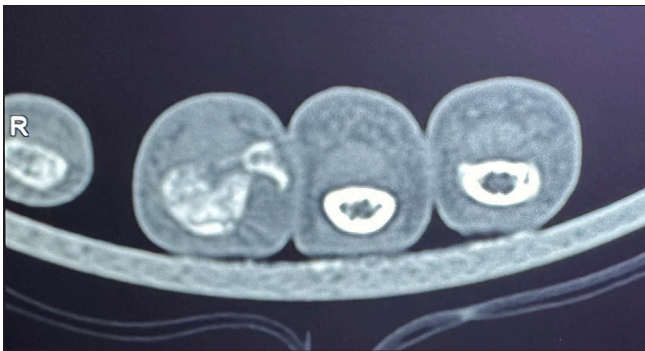
Figure 3: Axial computed tomography scan image showing the bone fragment rotated and displaced from the base of the middle phalanx.

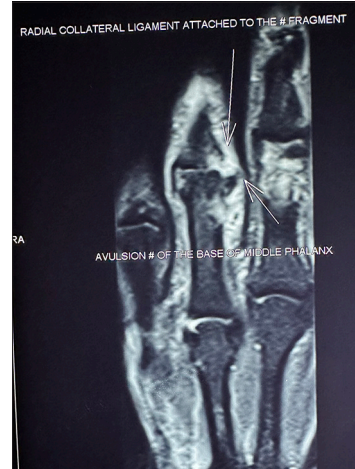
Figure 4: Magnetic resonance imaging confirming the volar plate and radial collateral ligament injury with the associated bone avulsion.

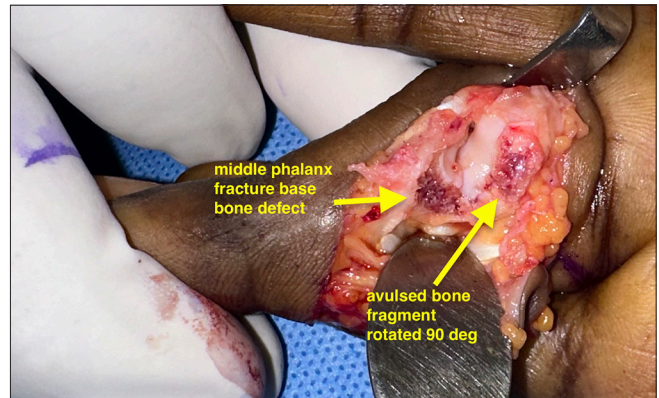
Figure 5: The intraoperative image reveals a 90-degree rotated avulsed middle phalanx bone fragment, with visible bone defects at the base of the middle phalanx.

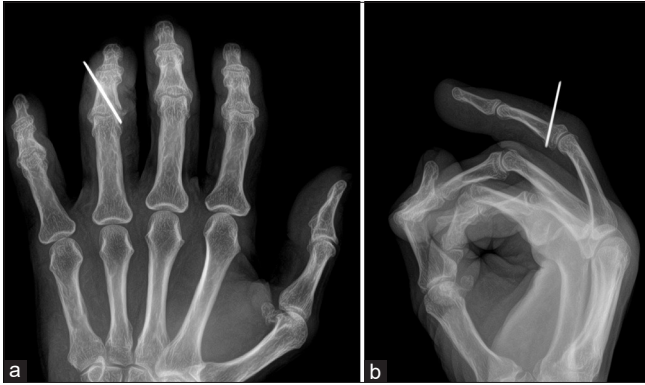
Figure 6: Immediate postoperative radiographs in the (a) anteroposterior and (b) lateral projections showing a well-reduced bone fragment restoring proximal interphalangeal joint congruity using a K-wire (white line).

Postoperative radiographs showed a well-reduced and congruent PIP joint with the K-wire stabilizing the avulsed bone fragment [Figure 6]. The finger was immobilized in a dorsal blocking splint, allowing immediate active flexion exercises.

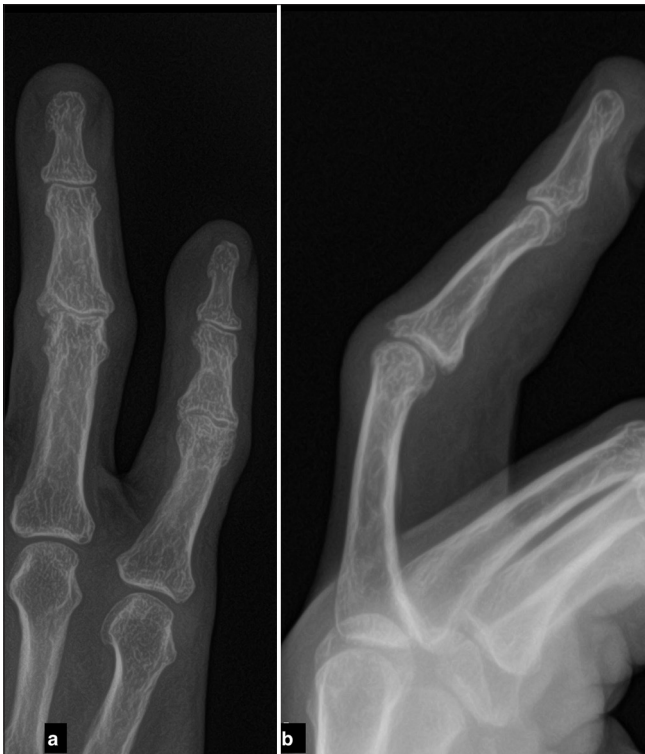
Figure 7: Follow-up radiographs at one year in the (a) anteroposterior and (b) lateral projections demonstrating good union of the bone fragment with a congruent proximal interphalangeal joint.

At 1-year follow-up, the patient had regained excellent range of motion of the PIP joint (5–110°). Final radiographs showed a congruent and stable PIP joint with complete healing of the middle phalanx base fracture [Figure 7]. At the 1-year follow-up, grip and pinch strength were measured as 25.4 kg and 4.9 kg, respectively. These values represented 90% of the patient’s contralateral, uninjured hand, indicating

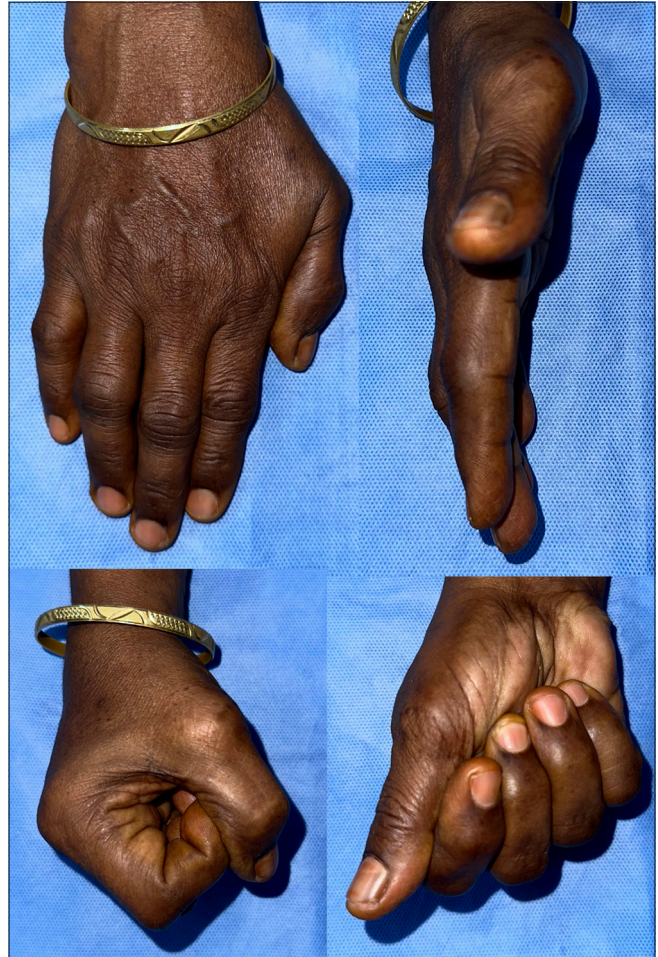
Figure 8: Clinical photographs of the right ring finger at one-year follow-up, demonstrating a good range of motion of the proximal interphalangeal joint.

a good functional recovery. Her Quick disabilities of the arm, shoulder, and hand (QuickDASH) score was 2.4, and her Visual Analog Scale (VAS) pain score was 0, indicating minimal disability and no pain. She was able to perform all her daily activities without difficulty [Figure 8].
